MILOP Design and Consulting Pty Ltd

RE: Concrete Boom Pump – Putzmeister model BSF28-4
Six Yearly Major Inspection - Certification
Report no 1799/21, 02/11/2021

Flowcrete Group Pty Ltd; Karboom Concrete, Putz BSF28-4, Six Yearly Certification, Report no 1799/21, 02/11/2021

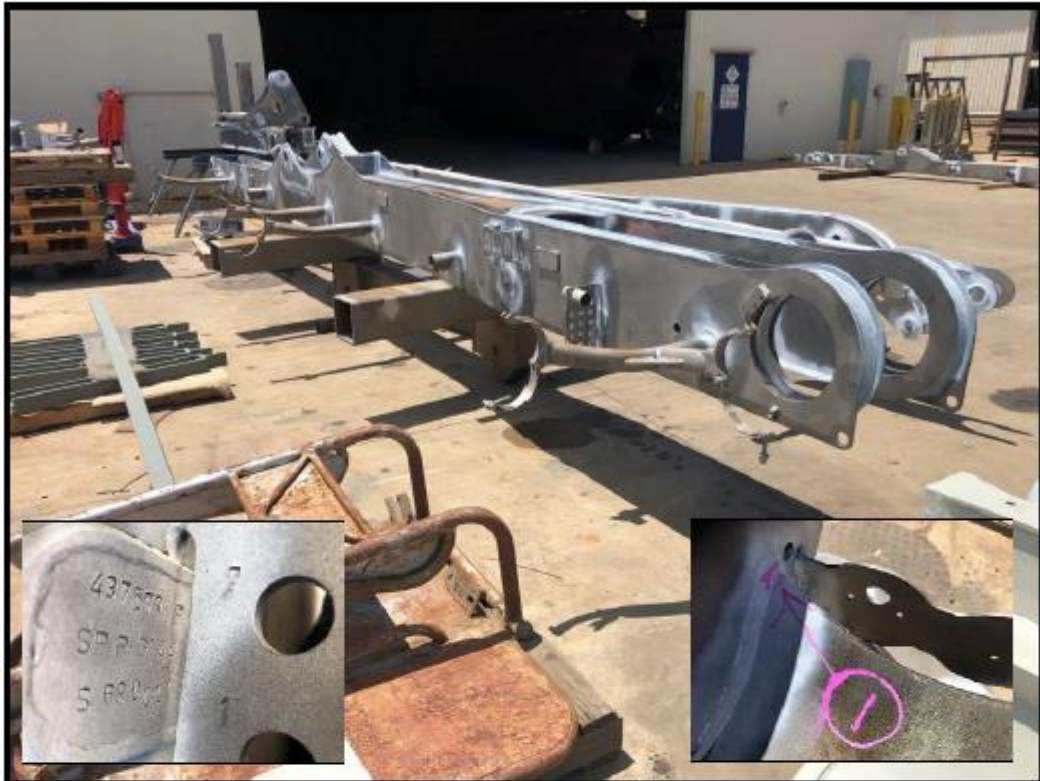
1st Stage Boom – 437579 E

MPI all accessible welds to main boom

1 crack evident

Crack was repaired and retested

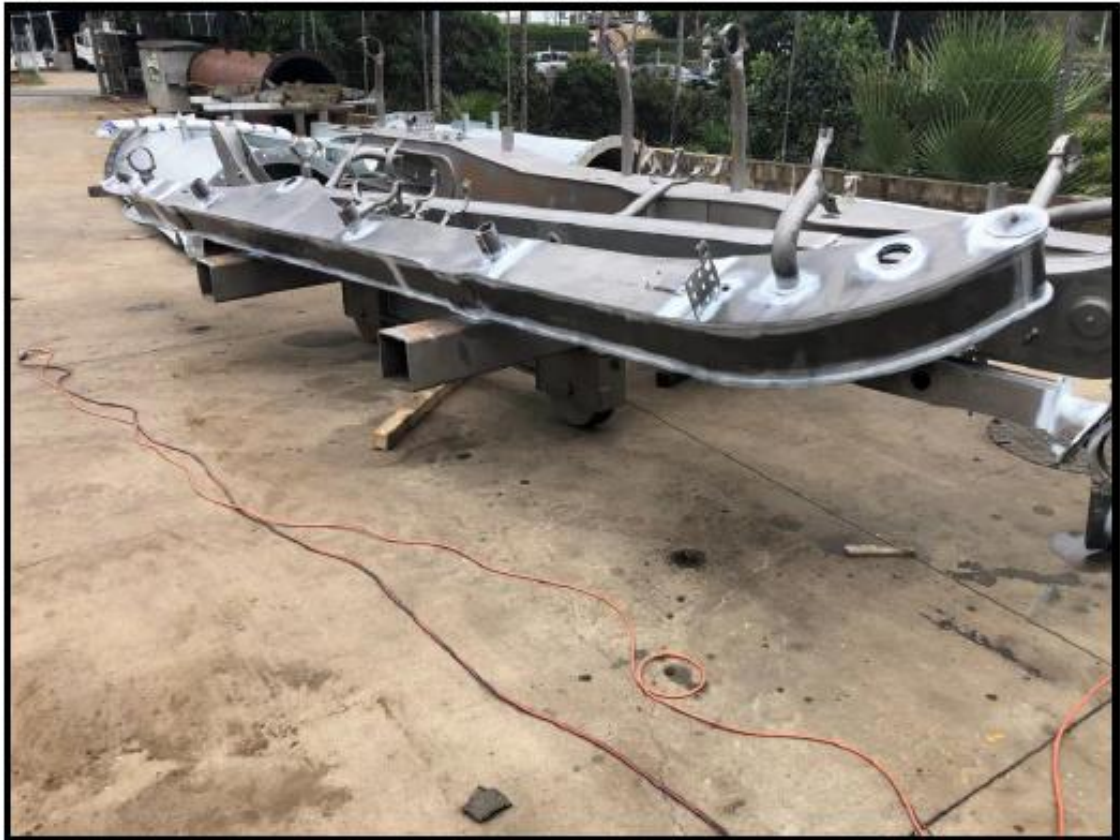
2nd Stage Boom – 437596 D

MPI all accessible welds to main boom

5 cracks evident

All cracks were repaired and retested

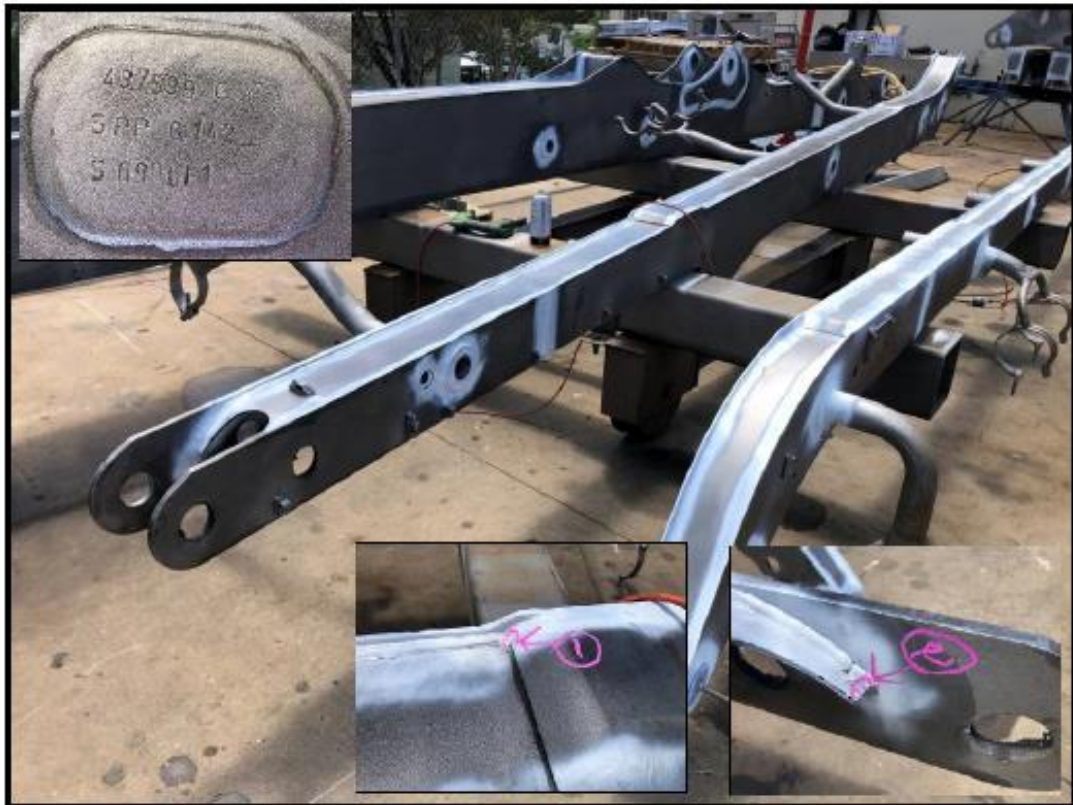
3rd Stage Boom – 437599 C

MPI all accessible welds to main boom

2 cracks evident

All cracks were repaired and retested

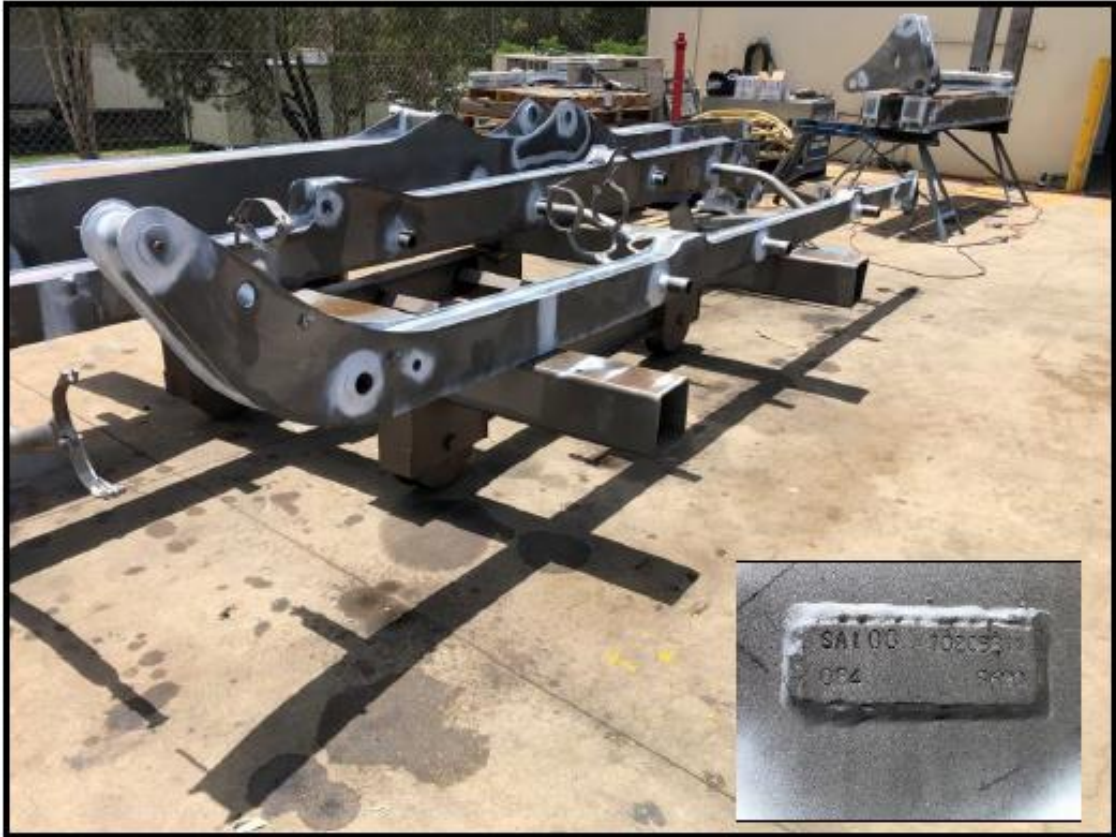
4th Stage Boom – 463482

MPI all accessible welds to main boom

4 cracks evident

All cracks were repaired and retested

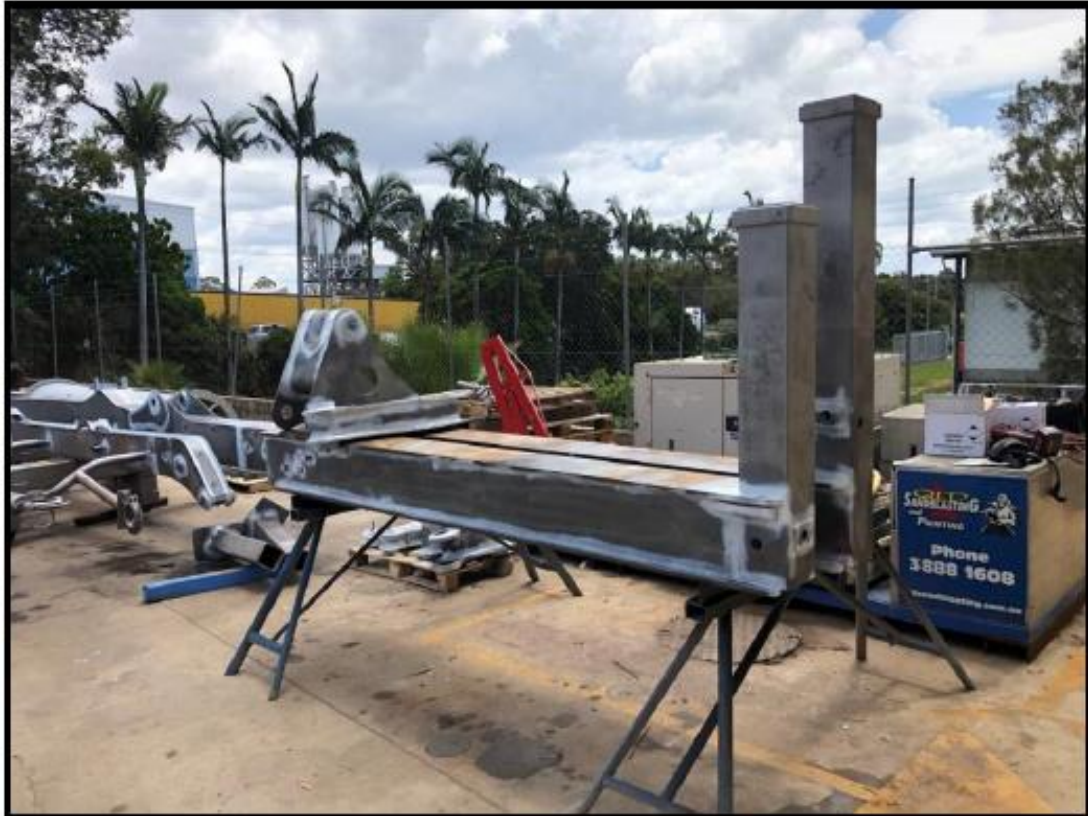
Outrigger Arms Qty. 2

MPI all accessible welds

3 cracks evident

All cracks were repaired and retested

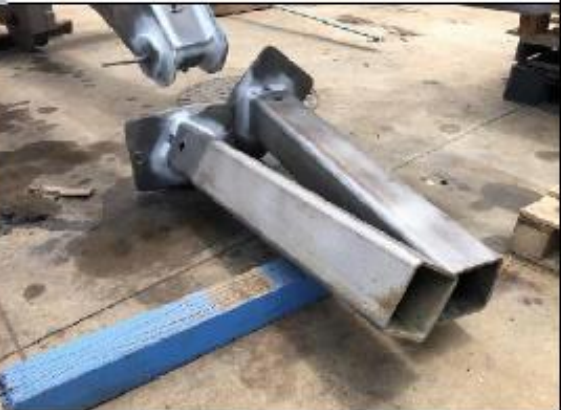
Photo 14

Outrigger Legs Qty. 2 (Photo 14)

MPI 100% of foot plate welds

Nil cracking evident

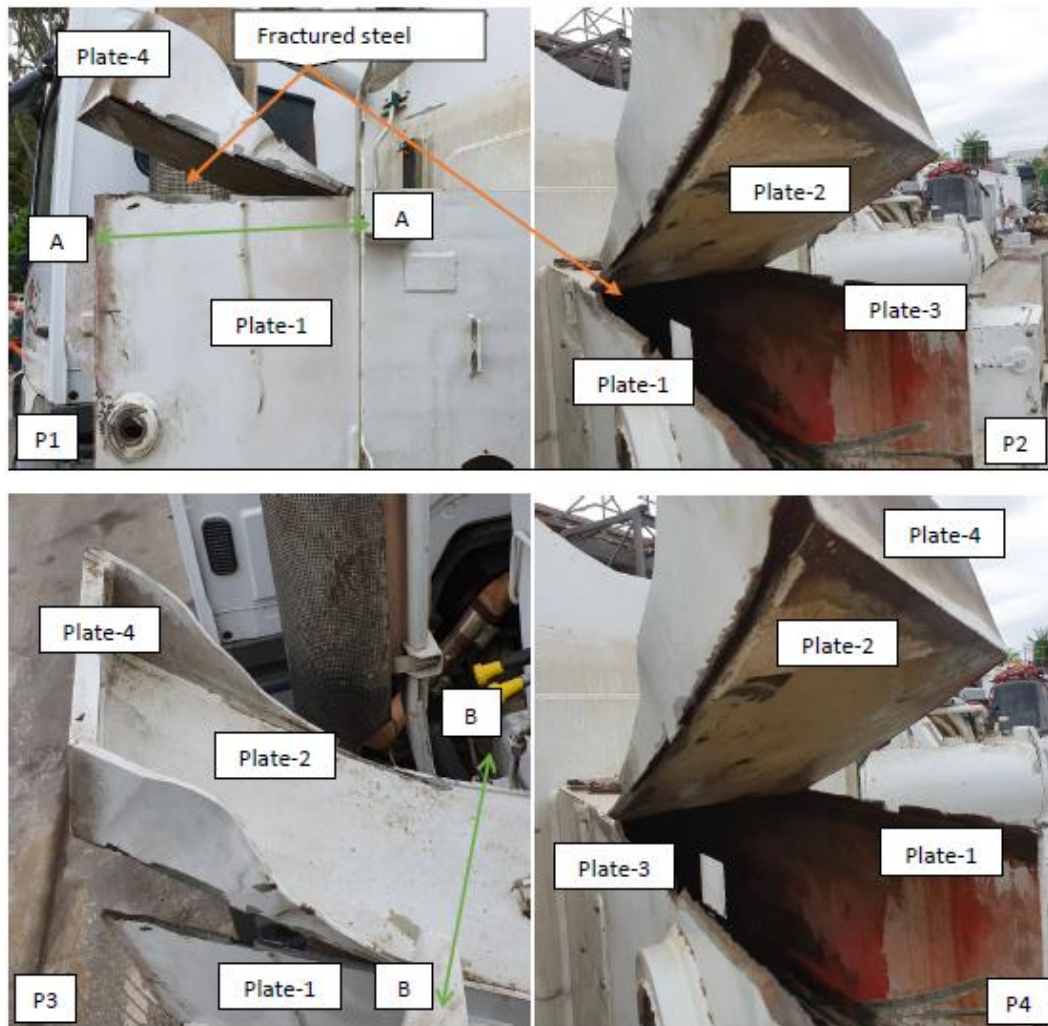
- 1. Overview of the fractured area and initial NDT testing.

Repair instruction for passenger side leg box damage due to the accident on 03rd June 2019.

Remove the paint from the fractured surface on plate 1 & 3 then carryout ultrasonic testing (UT) to find any lamination cracks below the fracture line, approximately 50mm downwards then horizontally to the end of the fracture line. Advise doing a magnetic partical test (MPT) to establish the crack propagation horizontally along the fractured surface/line. See photo 1 (P1) line A-A.

Carry out a hardness profile test (bottom part of plate 1 & 3, outside surface, below the crack line) vertically along the fracture line (100mm interval two locations) to determine the non-heat effected zone from the previous fillet weld, this was on plate 2 against the side wall (plate 1 & 3).

By performing the above initial testing 1 & 2, determine the horizontal cut line. This is to be butt welded with a new S690QL steel plate (replacing the deformed steel plate) above the fracture line on plates 1 & 3, as shown in photo P1.

Use only a cutting disk to cut the plates 1 & 3 on the horizontal plane. Never use the gas/OXY cutting process this will destroy the material mechanical property of the existing side plates.

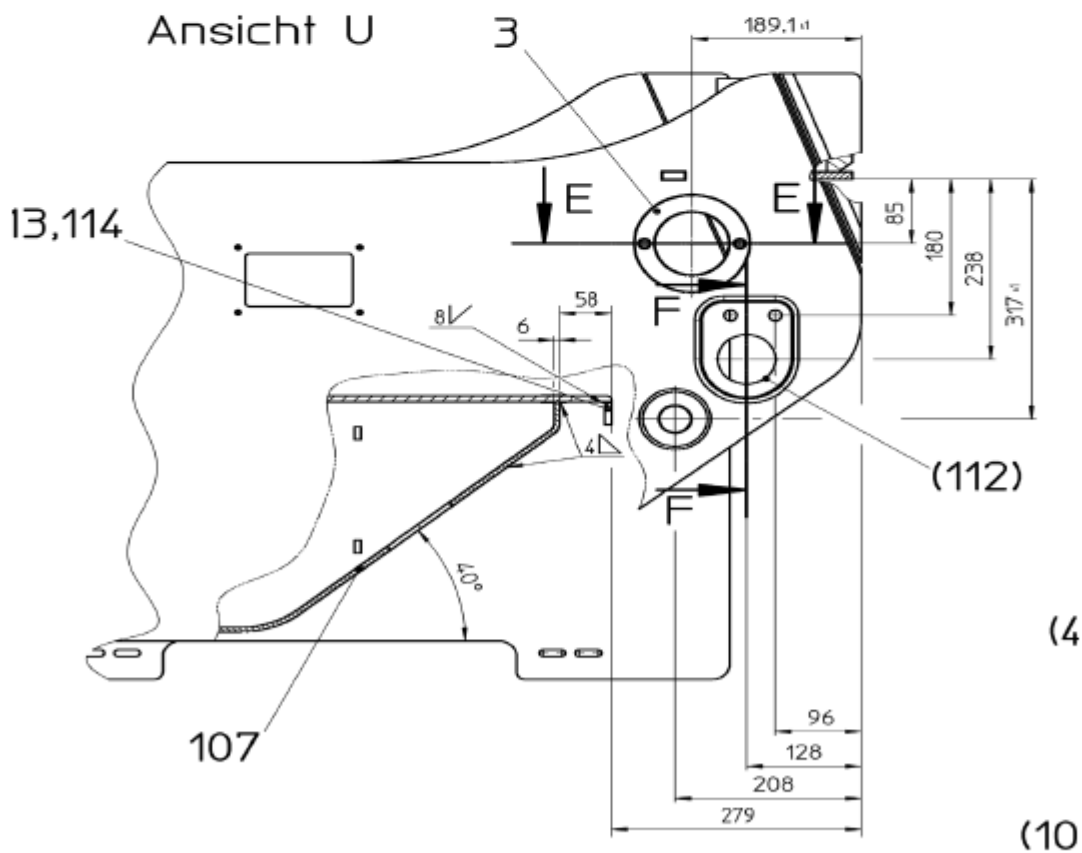
Step -2

Remove the paint on the bent surface of plate 2 then carryout ultrasonic testing (UT) to find any lamination cracks as a result of the bending. Mark the line B-B (as shown in the photo P3) on the passenger side leg box. Carryout MPT tests on the bent surface and check if any surface cracks are present.

If there are no lamination cracks found on the bent surface, mark 50mm from the B-B line towards the pedestal side and use this line as a proposed cutting line. This will be butt welded with a new S690QL steel plate, replacing the bent steel plate.

Details for a new plate -2 measurement for profile cutting are as shown in the drawing below, however final measurement should be based on the cut line defined above.

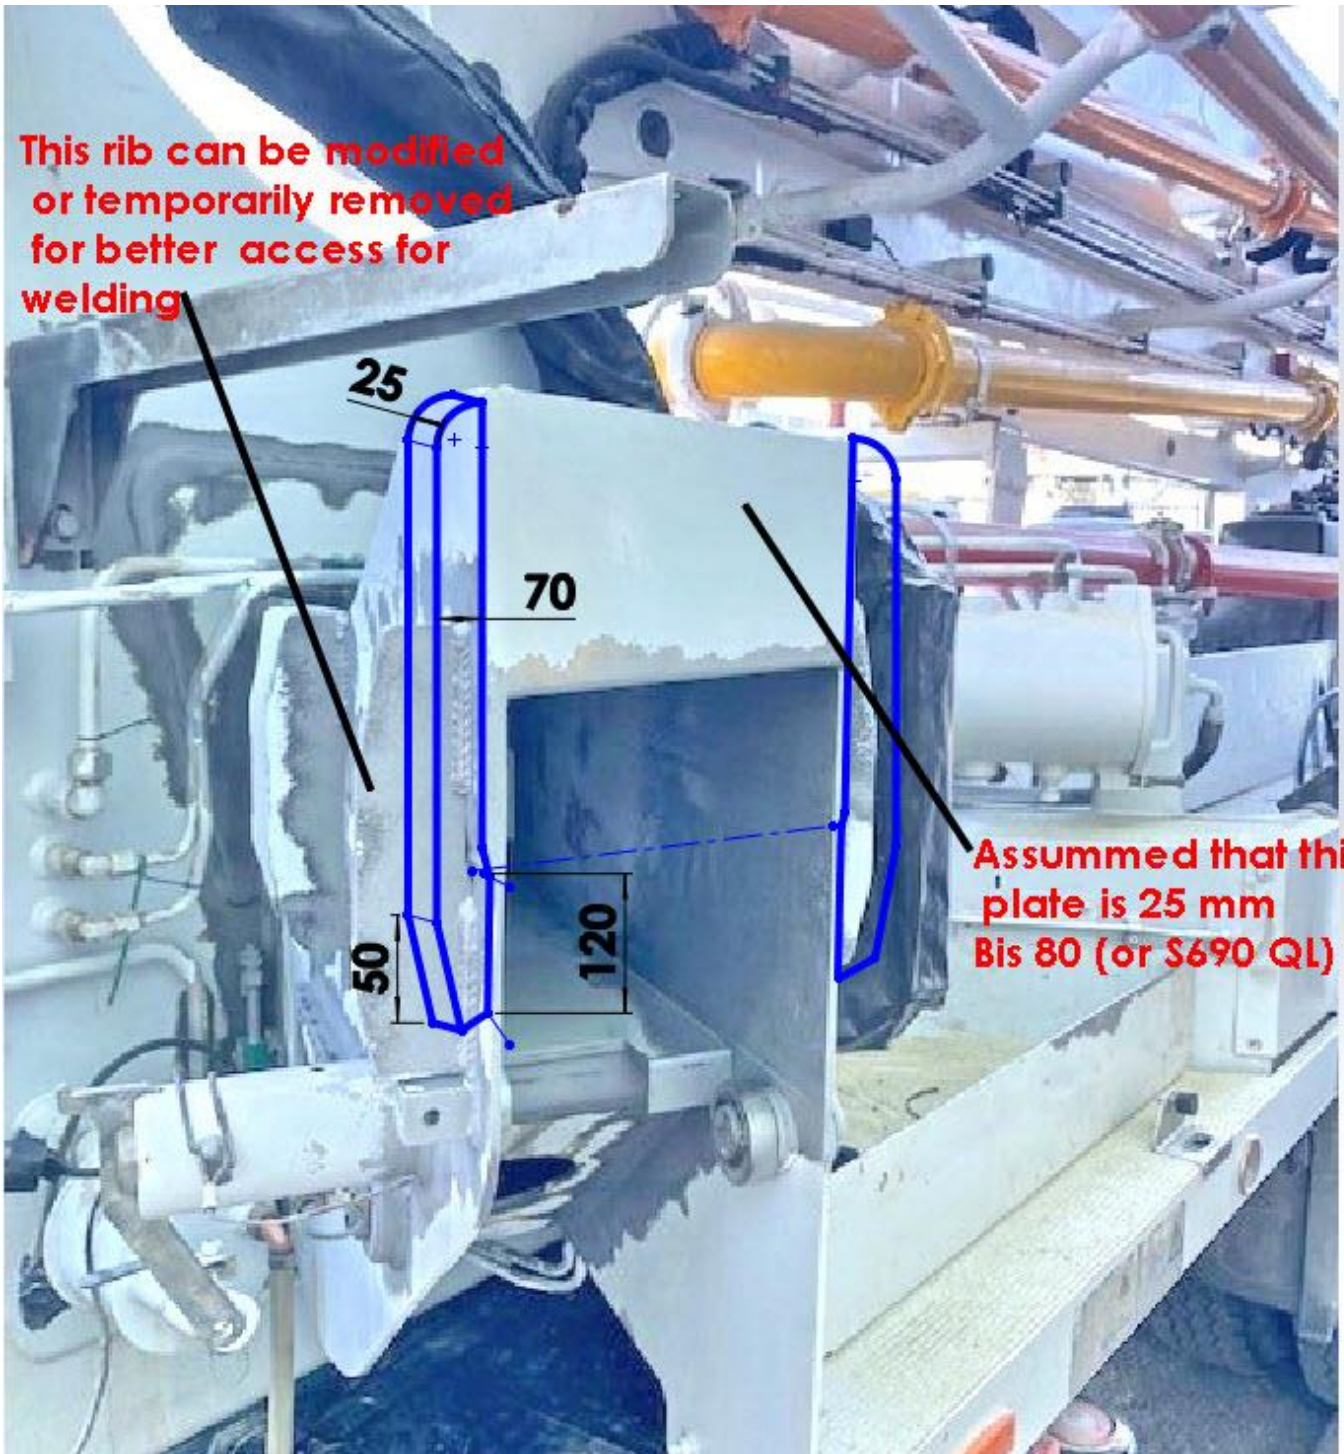
TOP VIEW ON STATIC BOX

The front left outrigger's static box was already repaired refer to the manufacturer's recommendations.

This repair neither improved nor strengthened this structural part of the machine.

Especially, it is important for short rigging, when the outrigger is partially opened, it could cause difficulties, depending on how the weld is reliable from the underside of the outriggers box.

So, an additional reinforcement plate would be useful and recommendable.

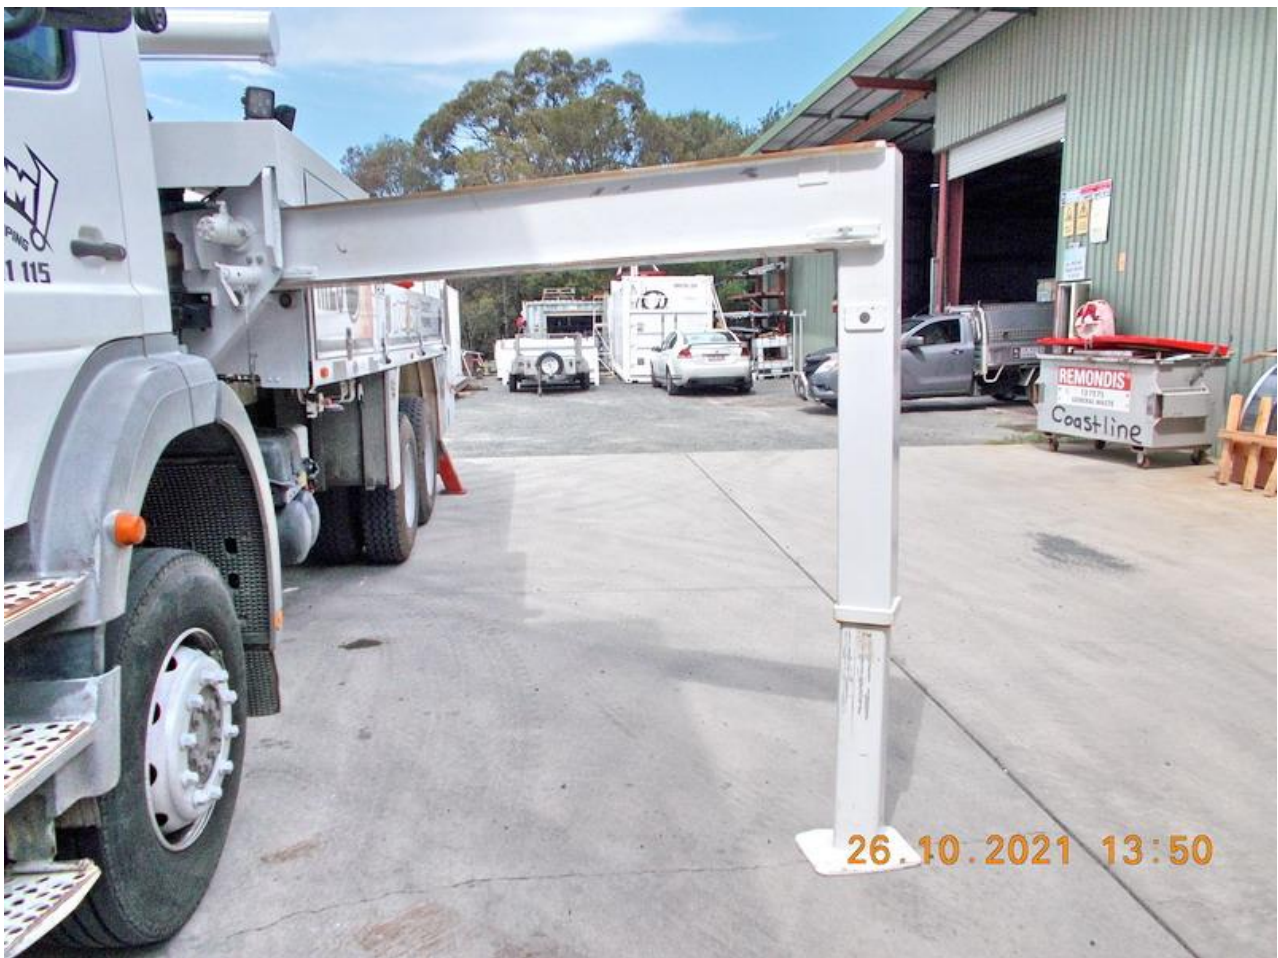
Fig 4. Testing over the repaired outriggers box

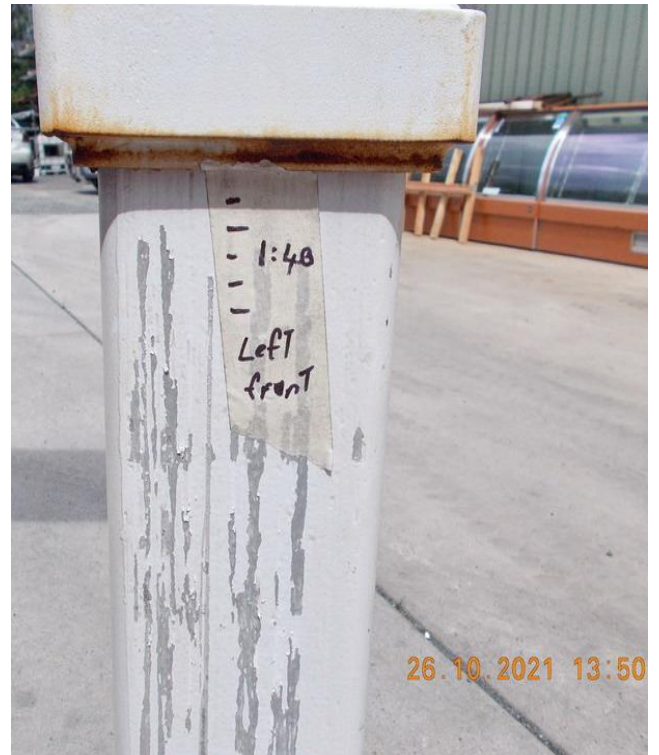
Fig 10. The The left front outrigger - Creep testing
